**A Watershed Conditions Report
For the State of Kansas
HUC 11030013
(Middle Arkansas Slate) Watershed**

Watershed Conditions Report For HUC 8 11030013 (Middle Arkansas-Slate)

Prepared by
Kansas Department of Health and Environment (KDHE)
Nonpoint Source Section
11/28/00

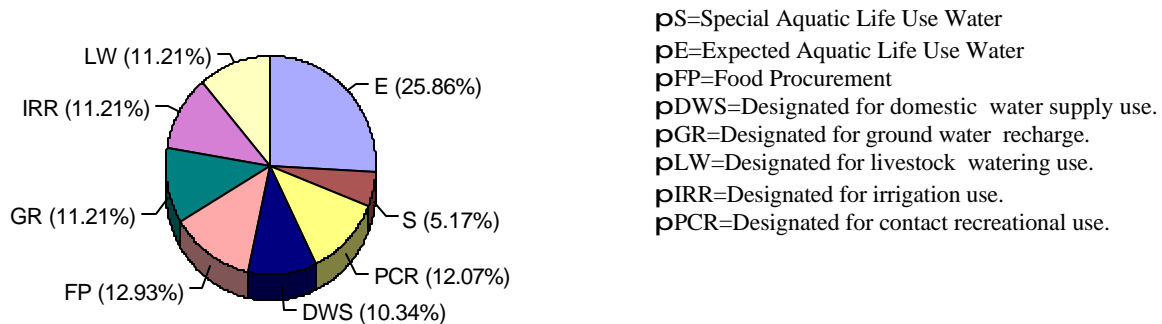
Figure 1

This watershed is mostly a drainage basin for the Arkansas River, however, several smaller streams, creeks, and rivers are also present throughout the area. There are 83 public water supplies within the watershed, many of which draw water from the Arkansas River and its alluvium. According to the Kansas Surface Water Register, the most common designated use for streams and rivers in this watershed include: aquatic life uses, food procurement; recreation, and groundwater recharge.

Huc 11030013 Surface Water Uses

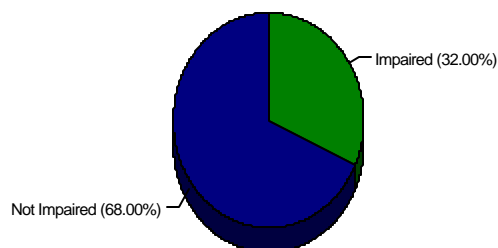
Surface waters not meeting their designated uses will require total maximum daily loads (TMDLs). Figure 2 shows 32% of the stream/river segments sampled need TMDLs. As shown below in figure 3, some of the primary pollutant concerns of this watershed's streams and rivers are fecal coliform bacteria (FCB), chlordan (chlordan), excess nutrients, chloride (Cl), and sulfate (SO₄). Approximately 27% of the stream and river segments are impaired by FCB, 23% by chlordan, 19% by nutrients, 15% by chloride, and 15% by sulfate (see Figure 3).

**Percentage of Stream/River Segments
Needing TMDLs**

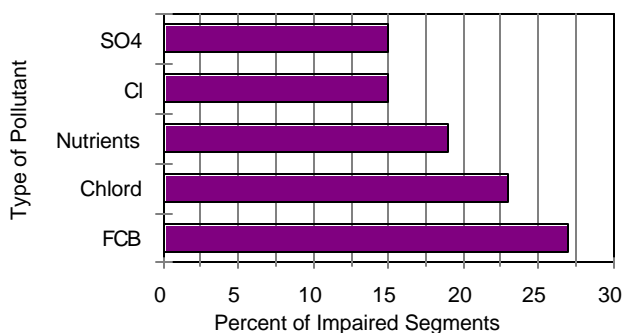
Figure 3

TMDL Distribution

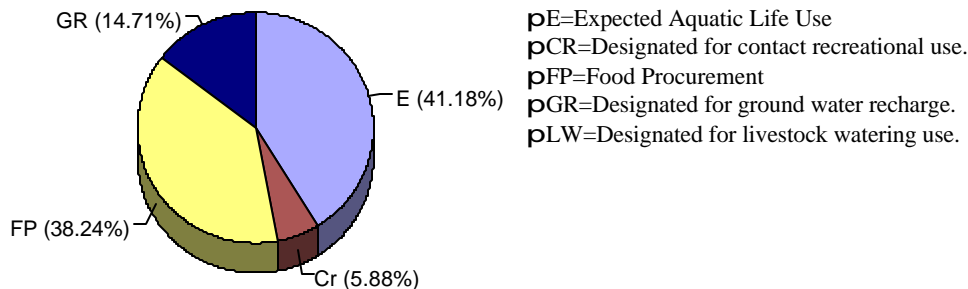
Figure 4

According to the Surface Water Register, the majority of the lakes and wetlands in this watershed are designated for expected aquatic life use, food procurement, ground water recharge, and recreational purposes.

Huc 11030013 Lake Uses

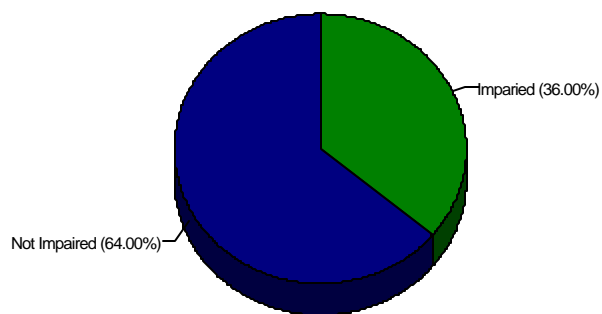
Figure 5

Surface waters not meeting their designated uses will require total maximum daily loads (TMDLs). Approximately 36% of this watershed's lakes/wetlands sampled need TMDLs (see Figure 4). Primary pollutants for this watershed's lakes and wetlands are eutrophication (E), chloride (Cl), pH, sulfate (SO₄), and silt. As shown below in Figure 5, approximately 56% of the lakes/wetlands in this watershed are eutrophic, and 11% are impaired by pH, chloride, sulfate, and excess silt.

Percentage of Lakes/Wetlands Needing TMDLs

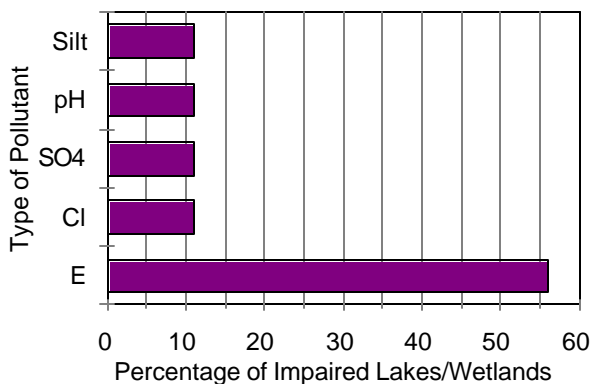
Figure 6

TMDL Distribution

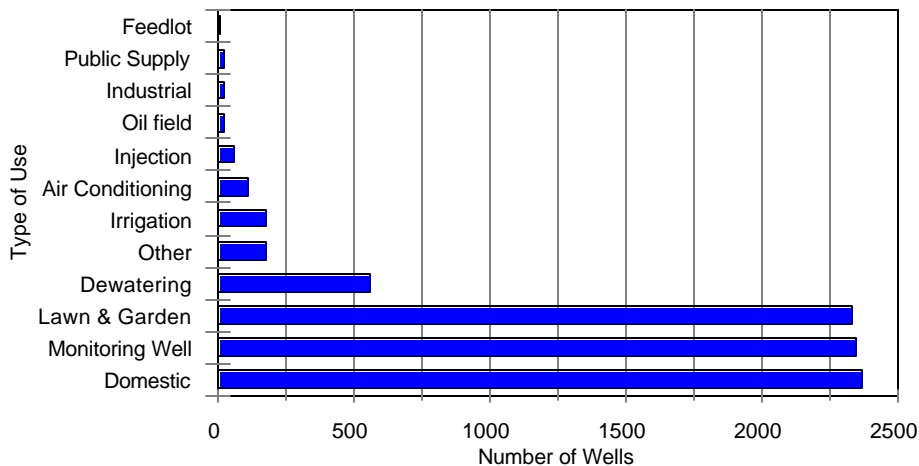
There are approximately 8,191 groundwater wells located within the watershed. Water from these wells is used for domestic use, monitoring, and lawn and garden.

Groundwater Uses

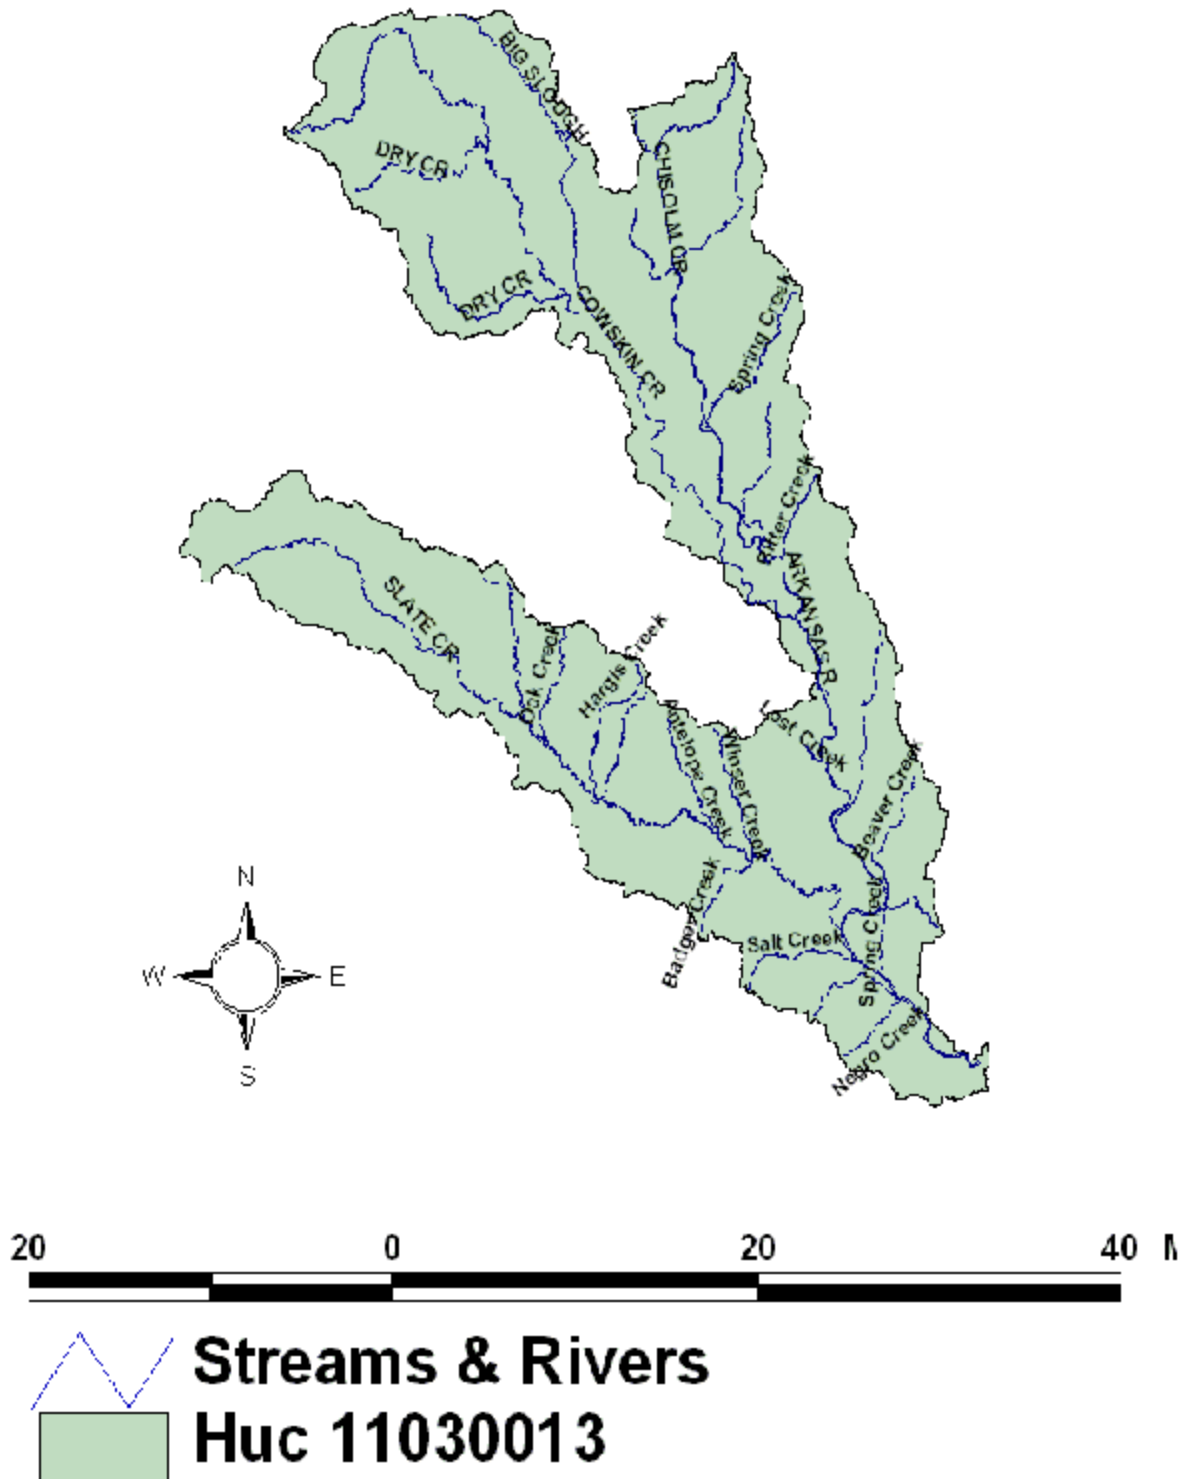
Huc -11030013- Middle Arkansas Slate Streams & Rivers

The Huc 8 11030013 watershed is ranked sixth in priority for watershed restoration throughout the state. According to the Unified Watershed Assessment, 43.4% of the total miles of water in this watershed do not meet their designated uses. The Arkansas River, Chisholm Creek, Spring Creek, and Cowskin Creek are among the larger streams and rivers. See Attachment 1 for a map of streams and rivers in HUC 8 11030013.

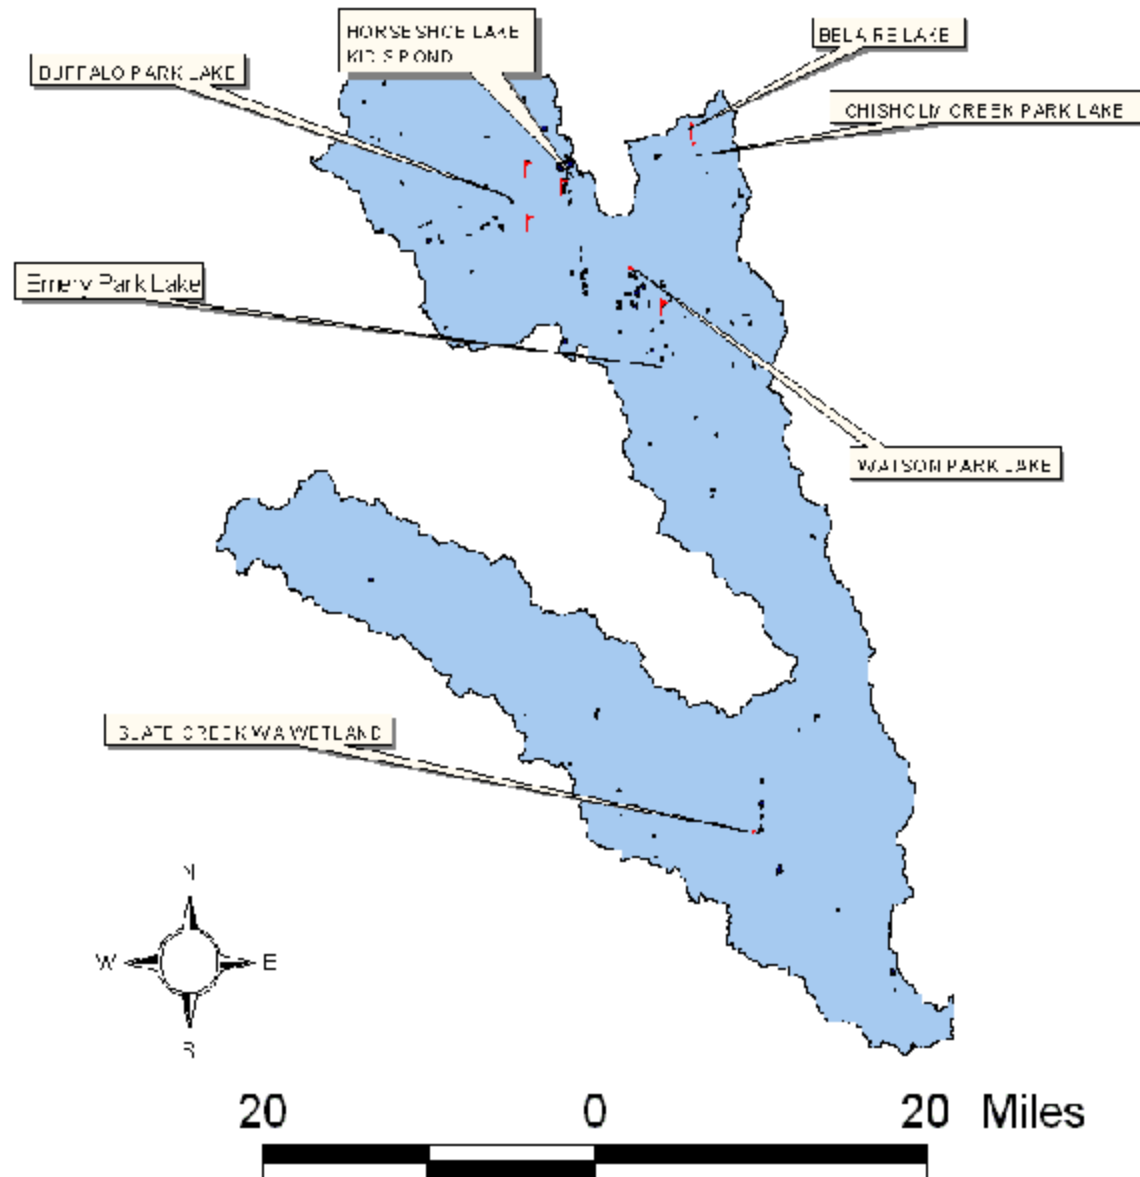
Huc -11030013- Middle Arkansas Slate Lake Monitoring Sites

- Lake Monitoring Sites
- Lakes
- Huc 11030013

Huc 8 11030013 is the home to several smaller city and county lakes, as well as two wetland areas. Many of the lakes are used for recreational purposes such as camping and fishing but for the most part they are used for food procurement. The wetland areas, otherwise known as the Pracht Wetland and the Slate Creek Wetland, occupy many aquatic species and filter runoff. Some of the smaller lakes in the watershed include Moss Lake, Watson Park Lake, Emery Park Lake, and Horseshoe Lake. See Attachment 2 for a map of lakes in HUC 8 11030013.

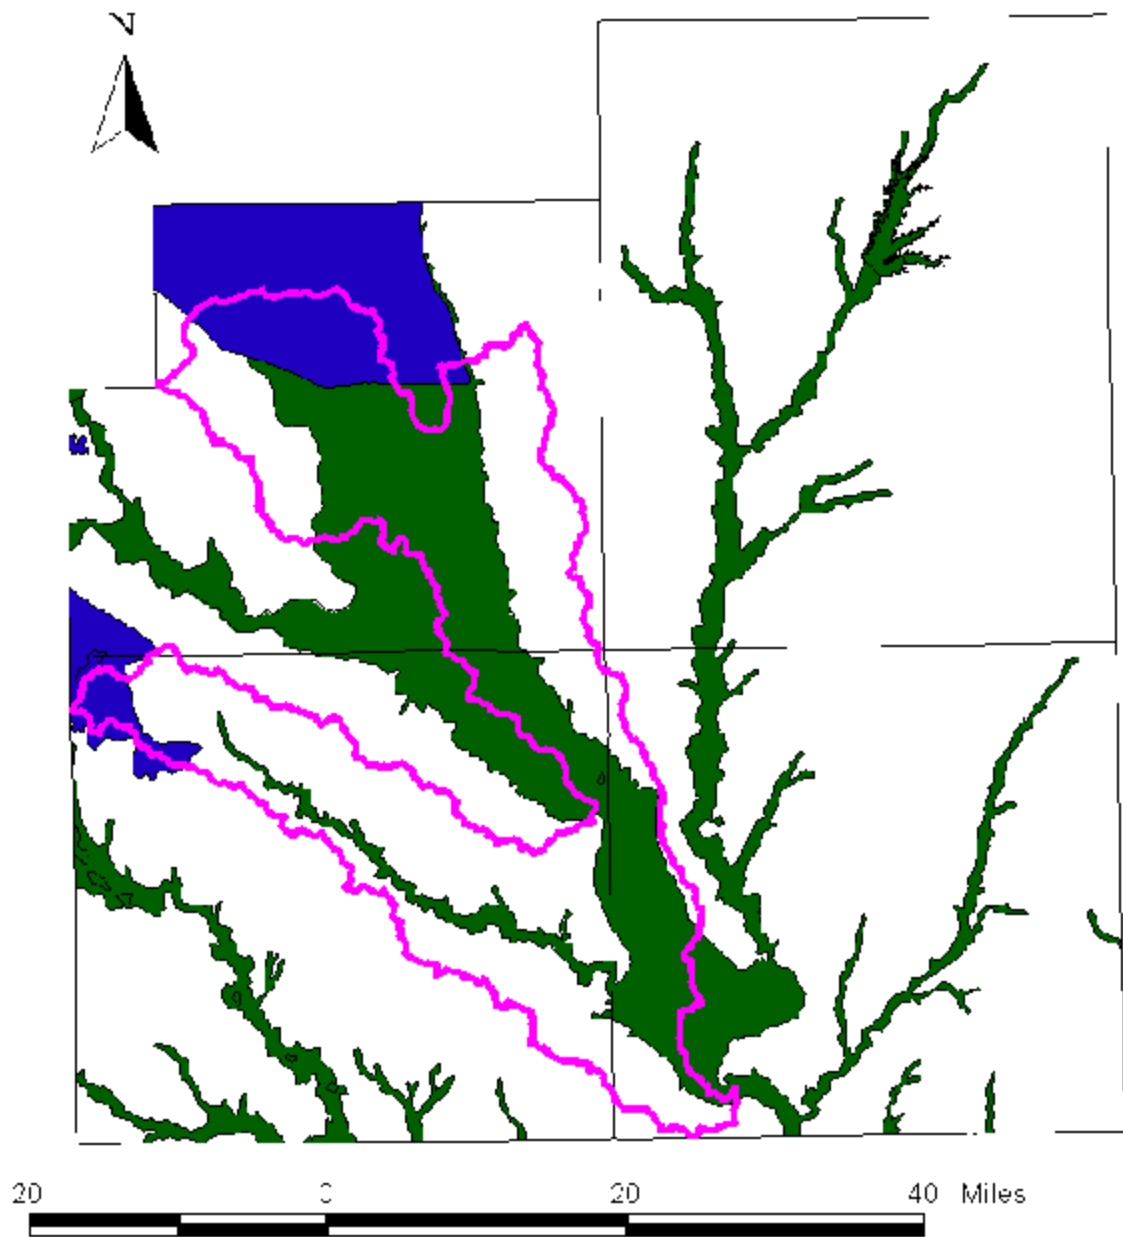
Huc 8 11030013 Middle Arkansas Slate Groundwater Aquifers

- Watershed Boundary
- County Boundary
- High Plains Aquifer
- Alluvial Aquifer

Major groundwater aquifers underlying this watershed include portions of the High Plains and alluvial aquifers of the Arkansas River and its tributaries. See attachment 4 for a map of the groundwater aquifers within this watershed.
